Highgate Disused Station R&E Fencing: Project Completion Report

Contract No.: 901

Main Contactor: Cleshar Contract Services

Sub Contractor: 7 Star Construction Services

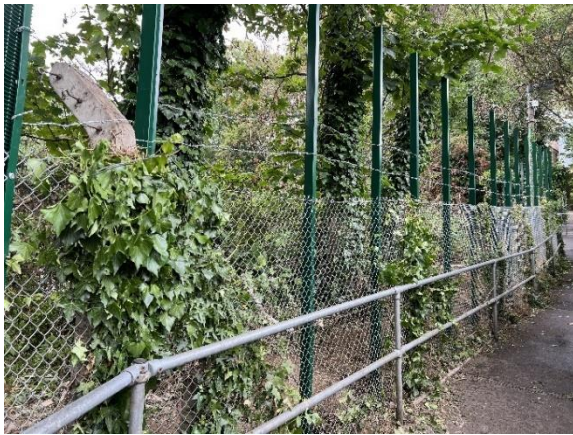
Figure 2 - Existing Chain-link Fencing removed.

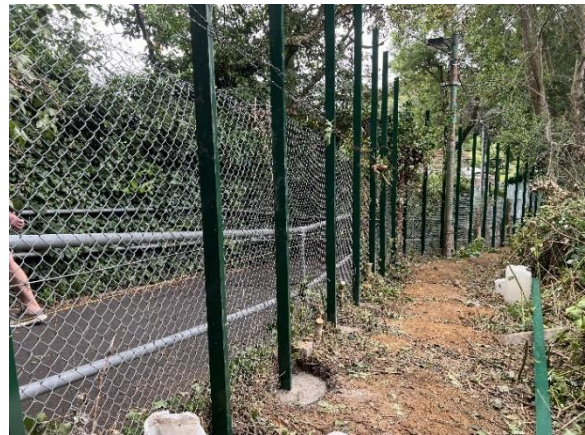
Figure 3 - Posts installed at 1m c/c to accommodate severe gradient.

- **Steep Inclined Slope:** Fencing works were carried out along a extremely steep inclined pathway making it labour intensive to transport materials uphill, increasing difficulty of the work especially during wet weather conditions.
- **Pedestrian Traffic:** Pedestrian traffic along the pathway posed challenges and potential safety risks, particularly during peak rush hours.
- **Difficult excavations:** Excavations proved difficult in this section with presence of desiccated strata due to tree roots and a deep concrete underlay to the pedestrian pathway. Excavations were more regular also since posts had to be installed at closer centres to ensure steps in the fence panels maintained a significant height to enhance security.

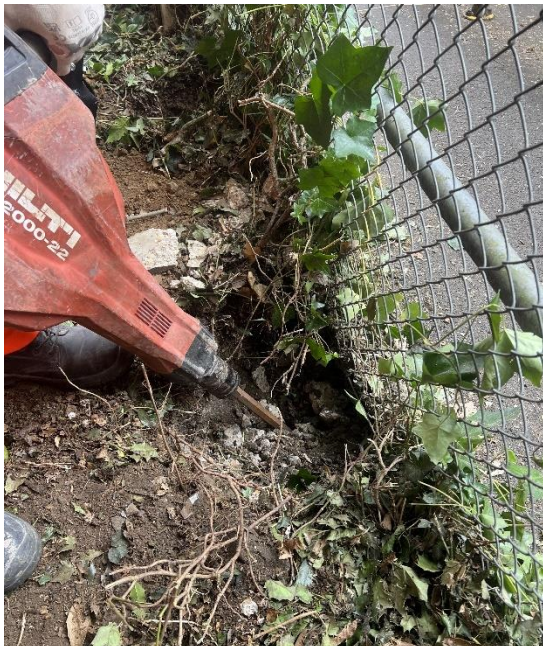
Figure 4 - Breaking out concrete underlay to pathway obstructing post excavations.

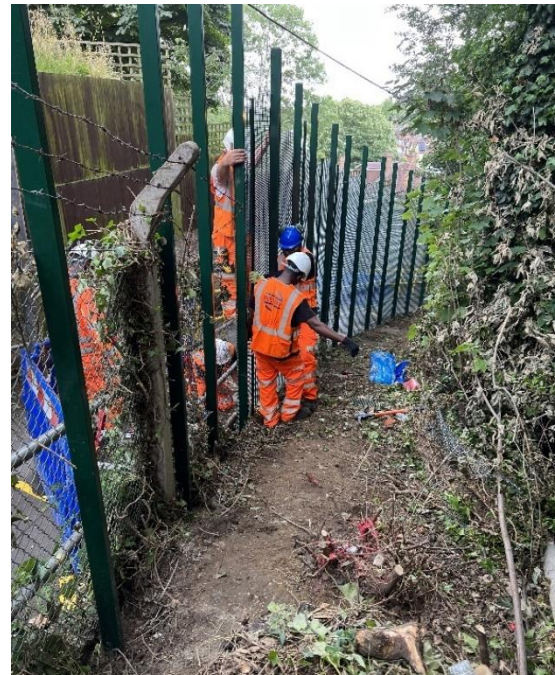
Figure 5 - Installation of panels along the 'Blue' section

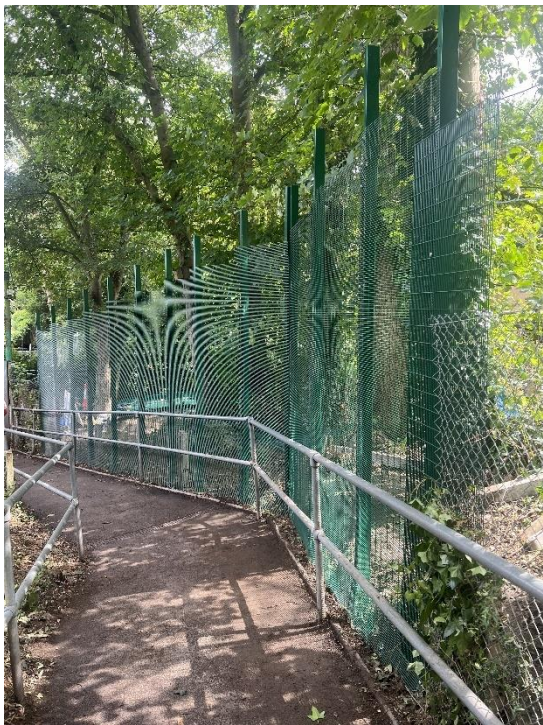
Figure 6 - External view of 3m inner skin installation.

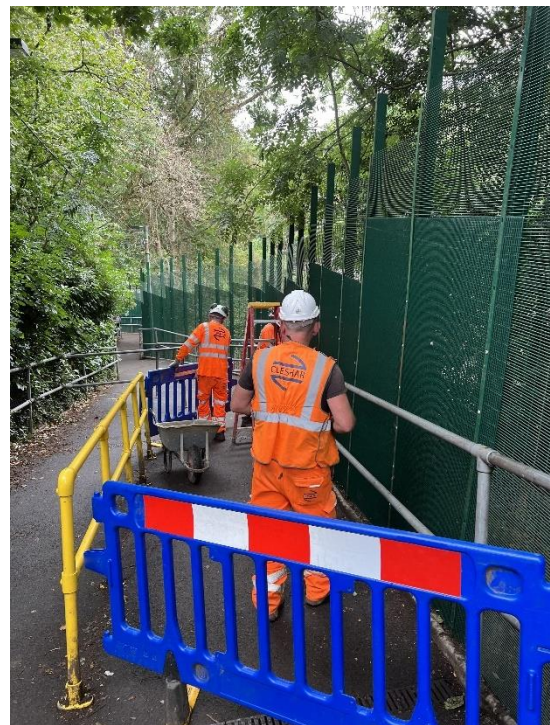
Figure 7 - Use of chapter 8 barriers along public pathway during installation of double skin panels along the 'Blue' section.

- **Timing of work:** Work along the pedestrian pathway was scheduled during lower traffic hours in the daytime to minimise disruptions to pedestrians.
- **Chapter 8 Barriers:** Chapter 8 barriers were utilized to physically separate the working areas from the public, ensuring safety during construction.
- **Hot Works Safety:** Hot works (i.e., grinder cutting mesh panels) was avoided in proximity to pedestrians. A designated watchperson was assigned to observe the pathway and signal when it was to start or stop cutting. Furthermore, all necessary hot-works permits were issued and displayed weekly, a designated fire watchperson was always present and there was always a valid PAC tested fire point within 20 meters of any hot works taking place.

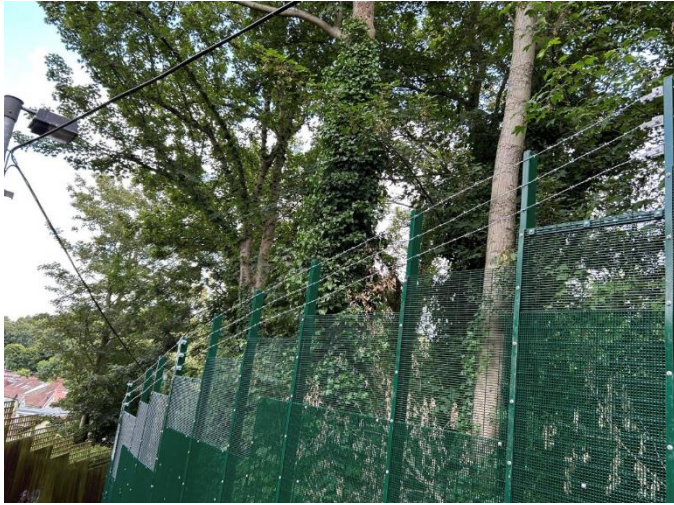
Figure 8 - Double skinned panels finished with 3 strand barbed wire topping.

- **Temporary Pathway Closure:** When it came to barbed wire installation, authorization was obtained to temporarily shut the pedestrian pathway during off-peak travel hours through the great work of Steve Witherspoon (Northern Line Station Interface Manager). This measure greatly assisted in installing the barbed wire both safely and efficiently.

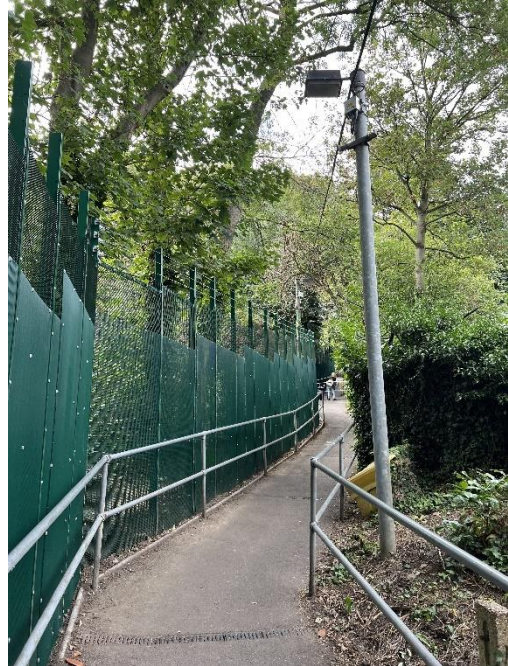
Figure 9 - Double skinned panels finished at the bottom of the pedestrian pathway.

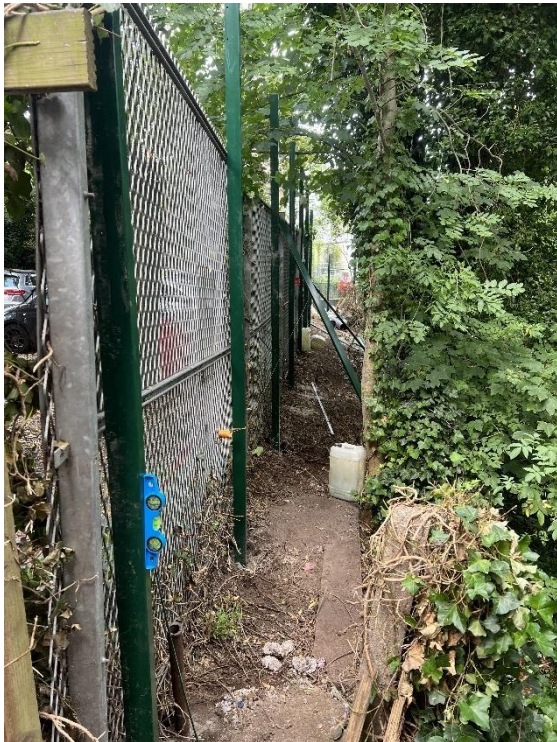
Figure 10 - Uneven ground conditions to working side of boundary.

- **Concrete Underlay to car park:** The presence of a deep C45 concrete underlay to the pub car park had to be broken out during post excavations.
- **Unstable ground:** There was an extreme sloping gradient on the disused station side of the boundary, which required some excavations to be dug almost 1200mm deep to ensure proper post placement in relation to the sloping ground.
- **Access difficulties:** Since the boundary formed part of the pub garden decking area, it meant working conditions were very tight to obstacles which needed to remain undisturbed.
- **Pub car park disruptions:** The pub car park was the only access to this section for deliveries, necessitating the minimisation of disruptions to customers and staff.

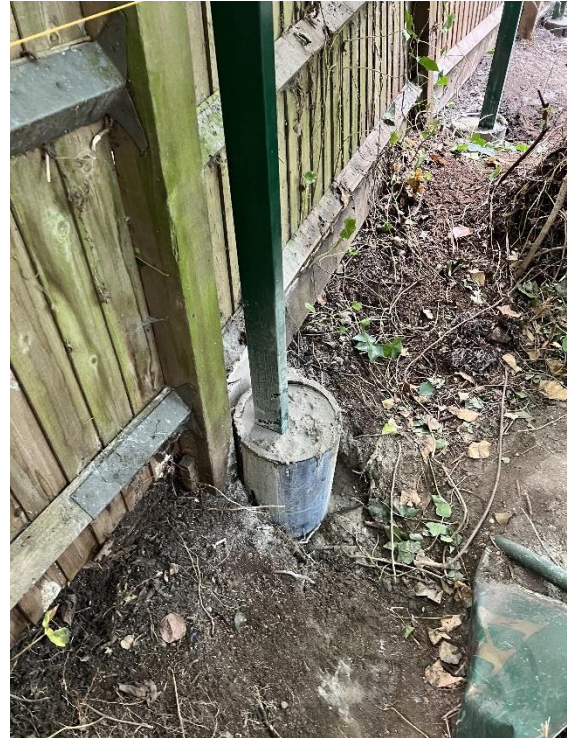
Figure 11 – Using ducts as permanent formwork to enable curation of postcrete footings in difficult ground conditions.

- **Ducts for post foundations:** Ducts were used for the post foundations, acting as permanent formwork for the postcrete. This ensured proper foundation formation in the presence of extreme uneven ground conditions.
- **Scheduling:** Noisy breaking out works were scheduled outside of peak customer hours to minimise disruption to the pub's operations and patrons.

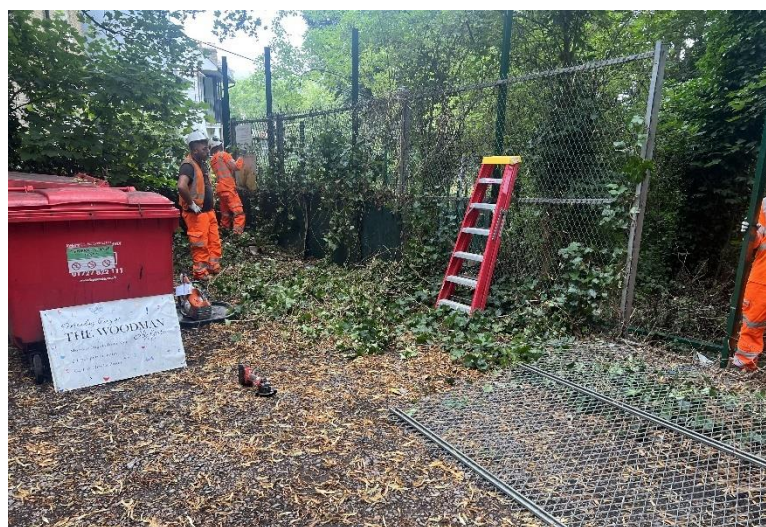
Figure 12 - Removal of existing rhomboidal mesh panels to pub car park

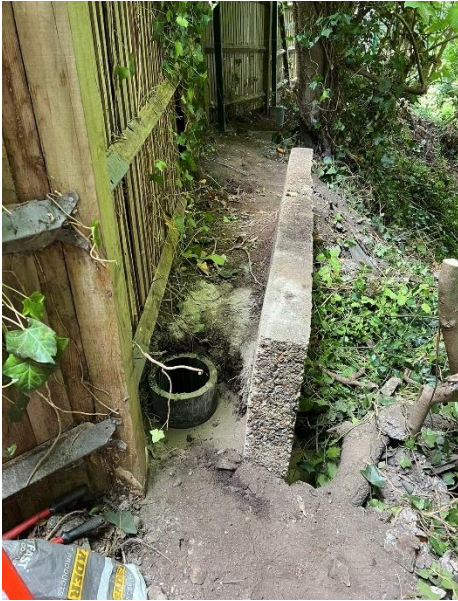
Figure 13 - Example of the difficult digging conditions with minimal space to use hand tools effectively.

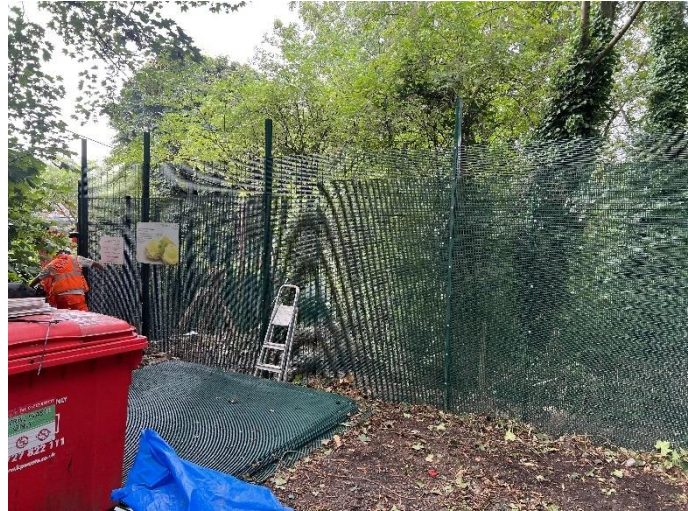
Figure 14 - New double skin prison mesh fencing installed and existing pub car park signage fixed back to new fence.

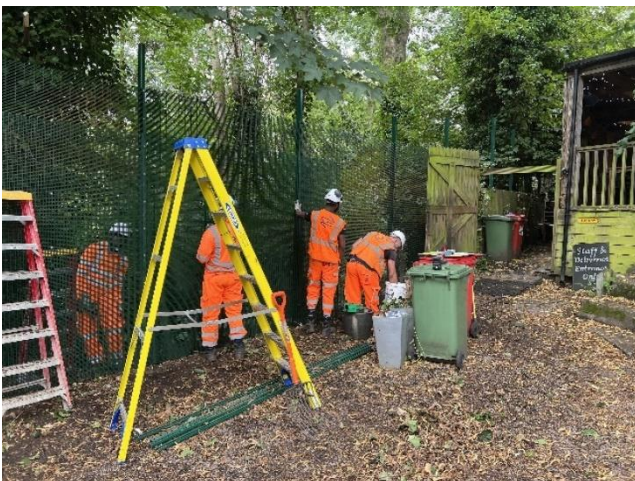
Figure 15 - Installation of double skin panels along pub car park boundary

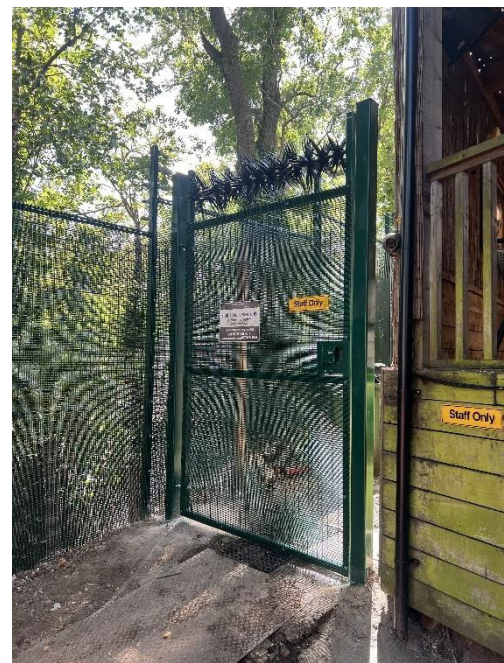
Figure 16 - New standard single gate topped with anti-climb raptors installed to pub staff entrance to enhance security.

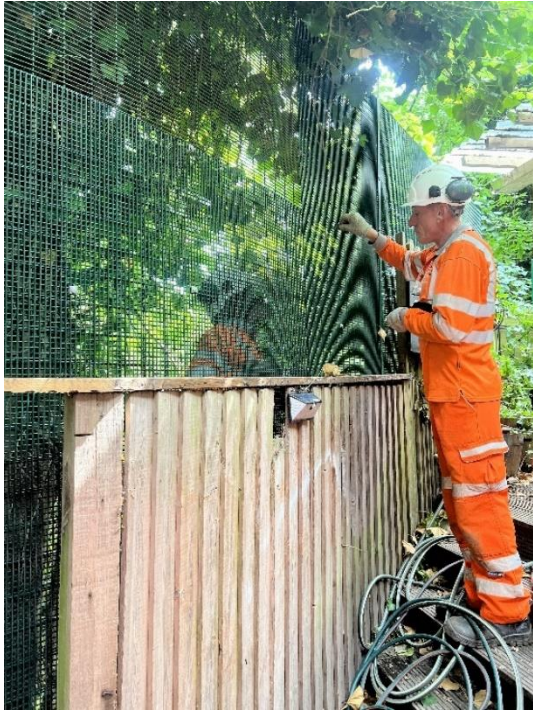
Figure 17 - Installation of double skin panels tight to decking of pub garden.

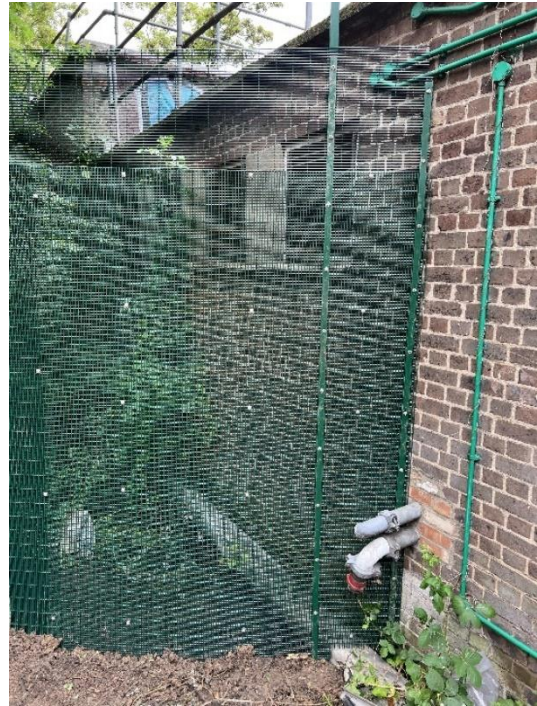
Figure 18 - Example of panels being trimmed around services using Unistrut's to stiffen cantilevered ends.

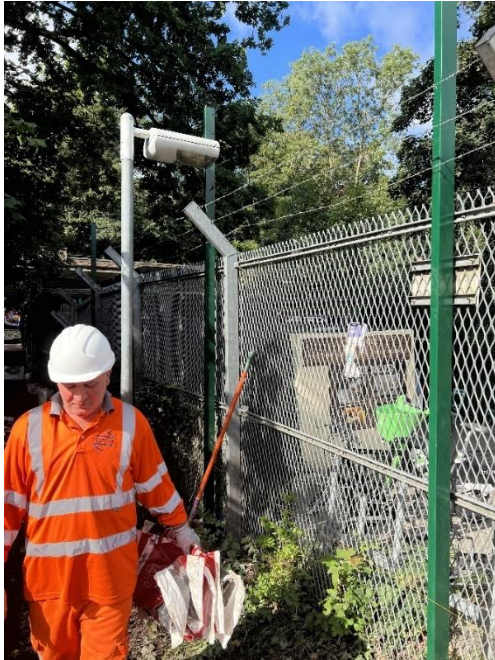
Figure 19 - Existing rhomboidal mesh panels and crank posts removed.

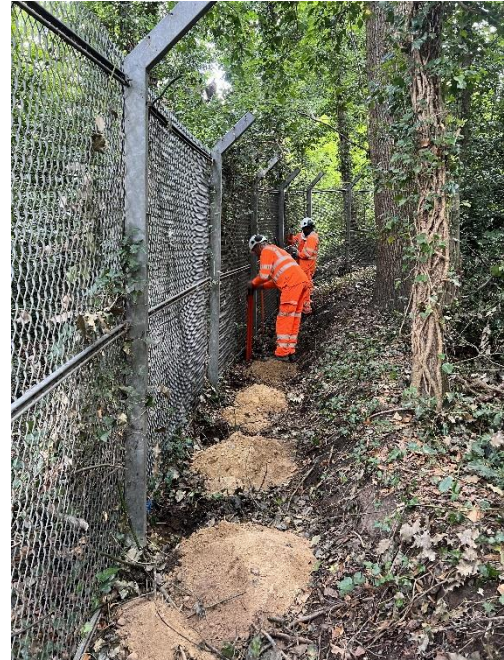
Figure 20 - Excavated piles of strong ballast strata.

- **Terrain:** Terrain was mostly loose topsoil and clay which became very slippery after heavy rainfall.
- **Excavations:** All ground during excavation consisted of dry ballast in this area which require breaking out with a T1000 Hilti breaker with a spade point.
- **Access:** Only access points for materials were at the start and end of this section run, requiring materials to be loaded out and transported long distances on tricky terrain by hand.
- **Roots and Vegetation:** An abundance of tree roots and vegetation was present resulting in additional obstacles when transporting materials and excavating post holes.

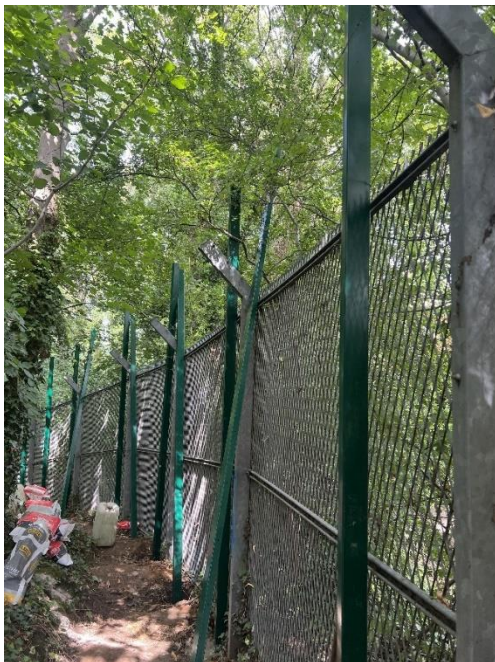
Figure 21 - Posts and postcrete loaded out at each hole ready for installation.

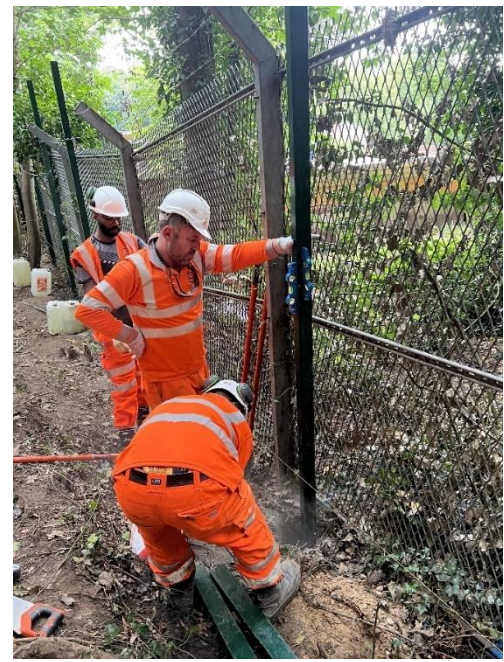
Figure 22 - Installation of posts along the 'yellow' section

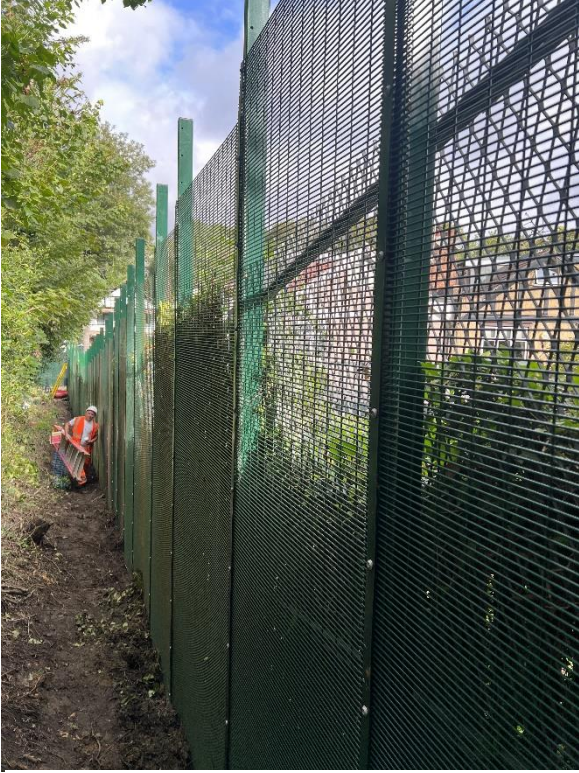
Figure 23 - Installation of single skin 3m fencing along boundary with No.87 Priory Gardens. Existing fencing left in-situ due to resident's outbuildings being fixed to said fence. Furthermore, it was a requirement of the resident to ensure that no vegetation was disturbed within their garden.

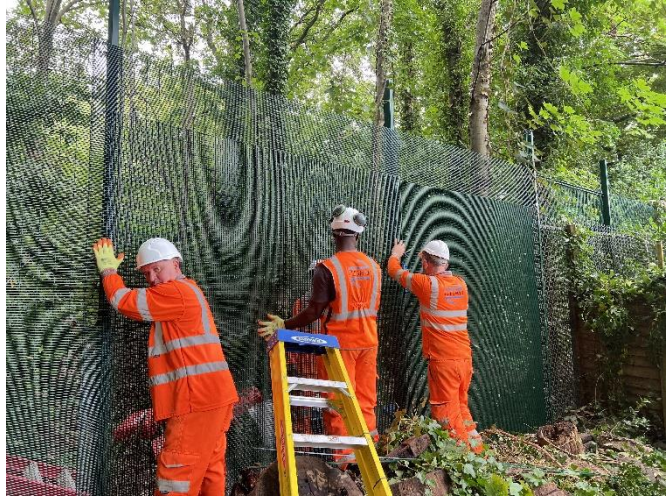
Figure 24 - Double skin resumed once fencing extended beyond the garden of No. 87 Priory Gardens.

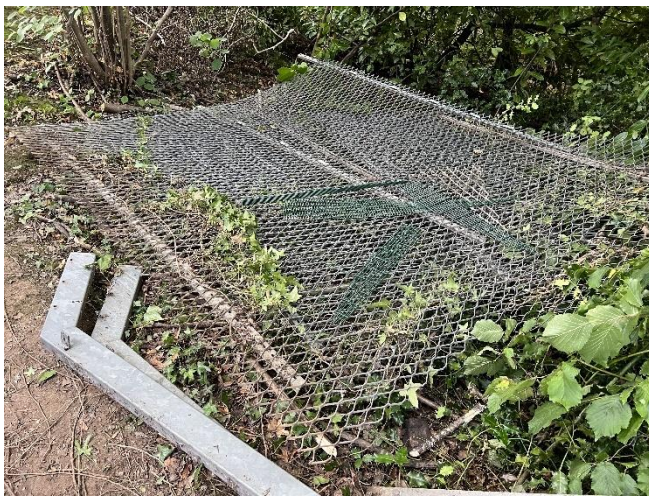
Figure 25 - Removal of existing rhomboidal mesh panels and cranked steel posts.

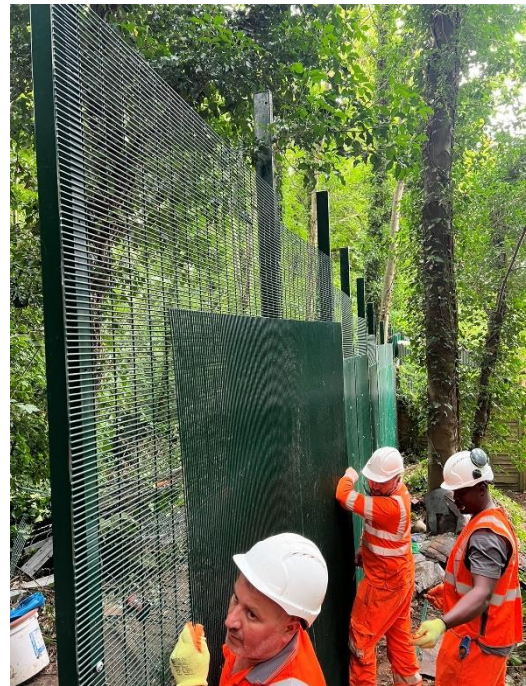
Figure 26 - Installation of double skin panels continued

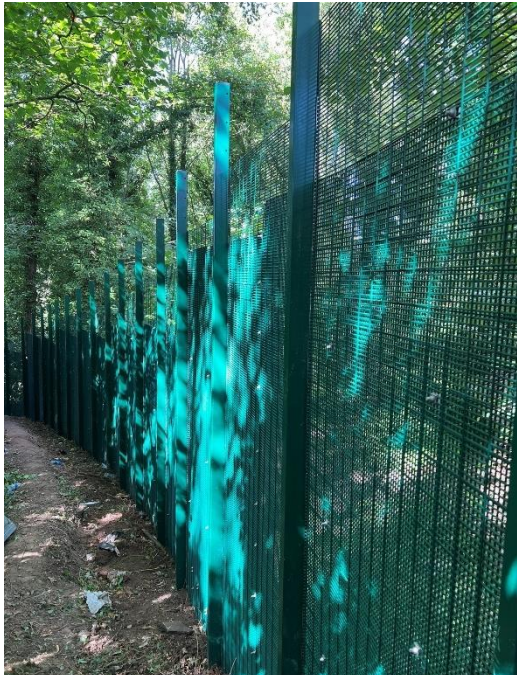
Figure 27 - Internal view of double skinned fencing along the 'yellow' section.

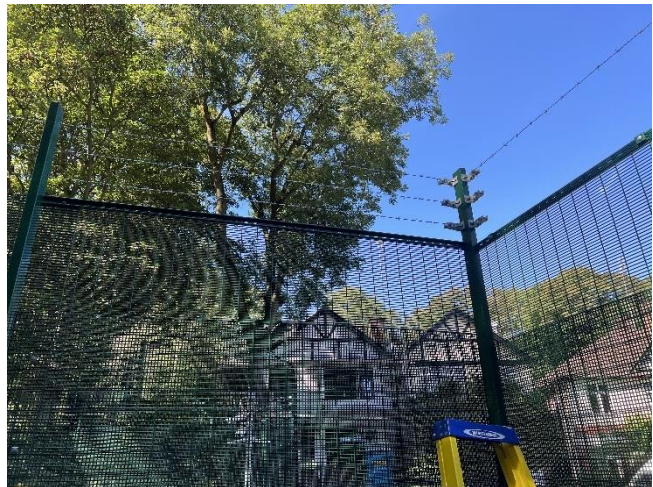
Figure 28 - Installation of 3-strand barbed wire to the rear of cafe Noir coffee shop at the priory gardens entrance to Highgate station.

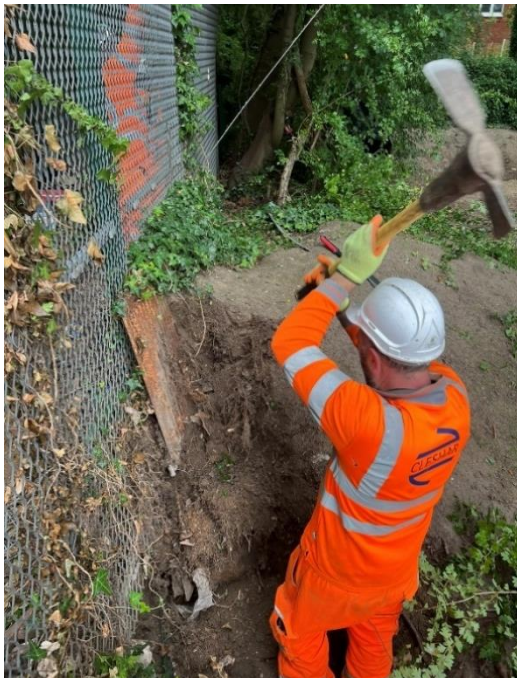
Figure 29 - Reducing raised external ground levels to install new fence panels.

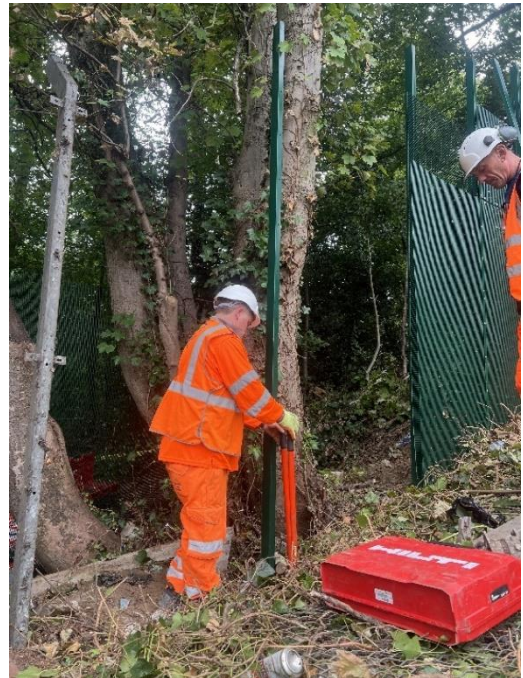
Figure 30 - Installation of final panels along the yellow run, severe sloping ground levels next to the entrance of the station car park.

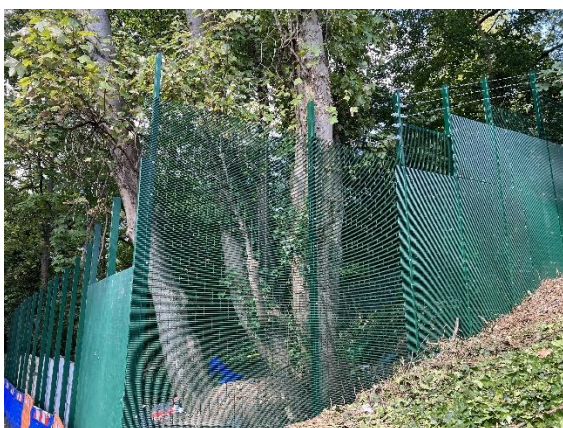
Figure 31 - Commencement of post installation along 'orange' section & completion of corner with 'yellow' section.

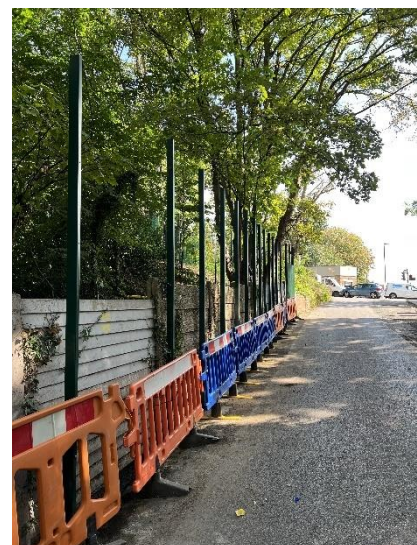
Figure 32 - Chapter 8 barriers sectioning off newly installed posts at the end of the shift.

- **Chapter 8 Barriers:** Chapter 8 Barriers were used to create a physical barrier between the working area and vehicles entering and exiting the car park, enhancing safety for both workers and drivers.
- **Retaining the tarmac threshold:** It was decided that the best approach to retain a strong edging threshold between the tarmac and the boundary would be to leave the low level concrete panels in place along the full length of the station car park to retain sufficient support and haunching along the edge of the road.

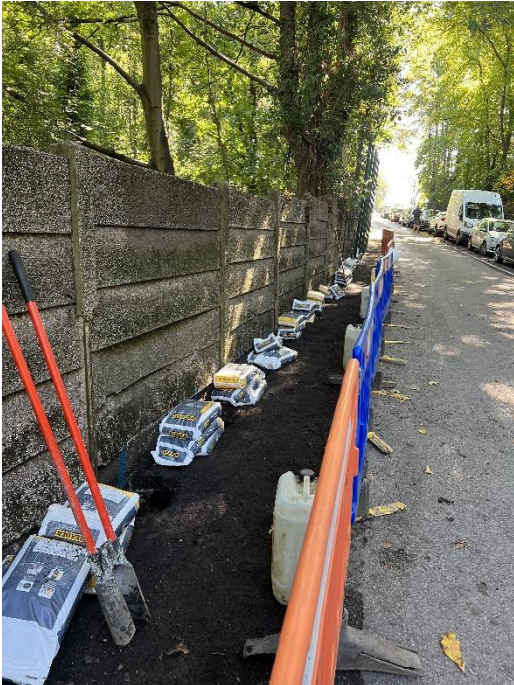
Figure 33 - Excavations along car park boundary, postcrete loaded out, also showing existing concrete fencing to be removed.

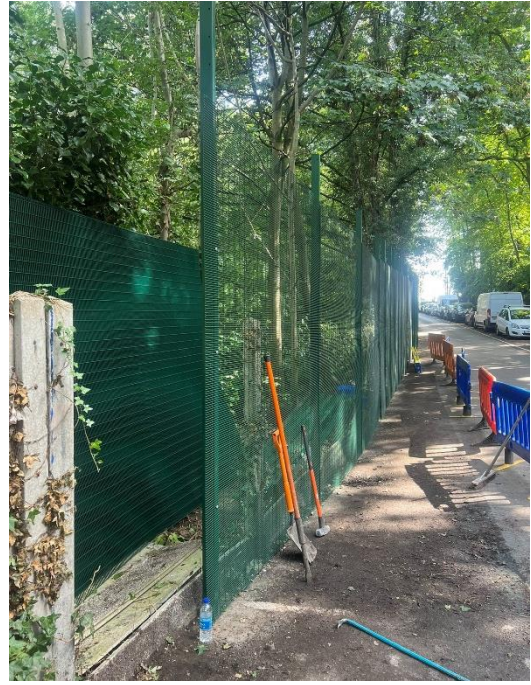
Figure 34 - Car park boundary fencing single skinned and existing concrete panels removed.

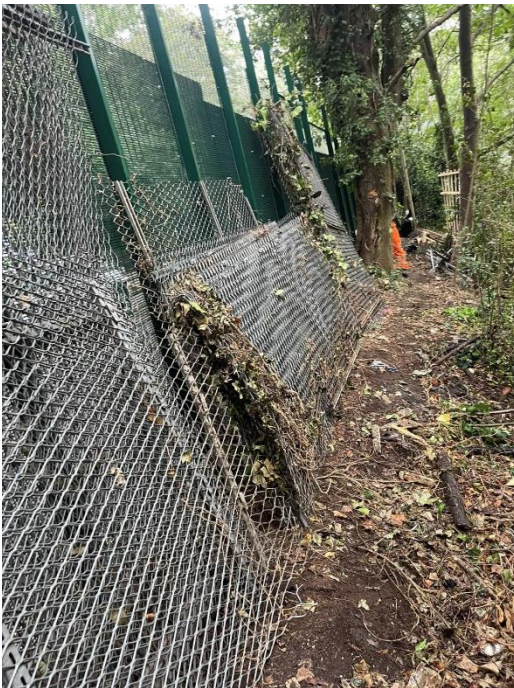
Figure 35 - All redundant scrap and waste material piled in one location ready to be loaded onto the flatbed truck.

- **Working proximity to Car Traffic:** Working near cars entering and exiting the car park, which required special attention to safety and traffic management.
- **Difficult Excavations:** Difficult excavations due to the presence of strong concrete underlay and tarmac within the car park which was to be retained and therefore subject to minimal disruption.
- **Labour intensive Panel Removal:** The labour-intensive process of removing heavy concrete panels, which had to be loaded onto a flatbed truck by hand and removed from site every day.

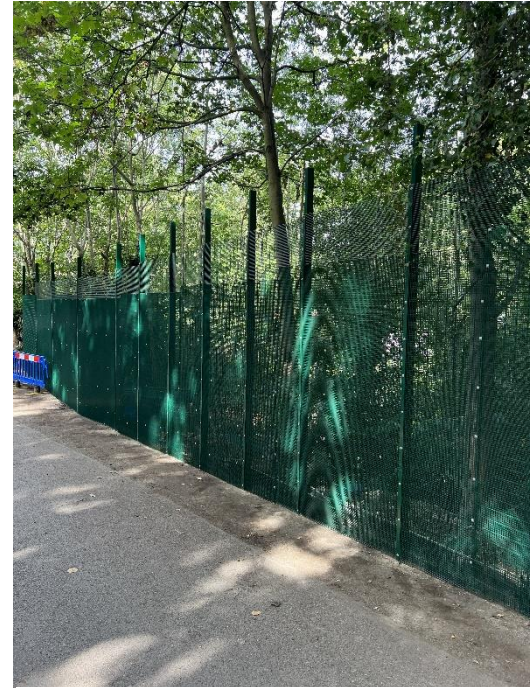
Figure 36 - New double skinned 358 prison mesh fencing installed along car park boundary.

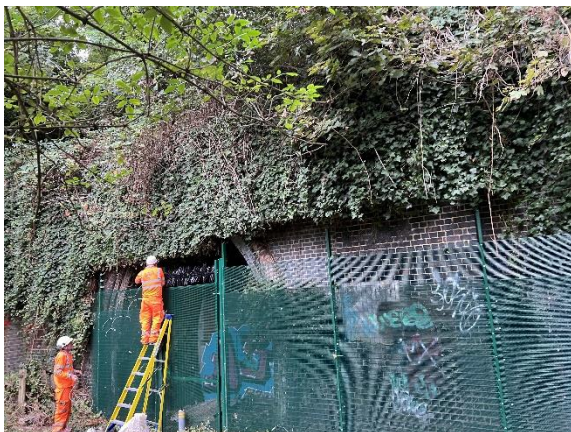
Figure 37- Installation of 3-strand barbed wire topping to fencing in front of the tunnels.

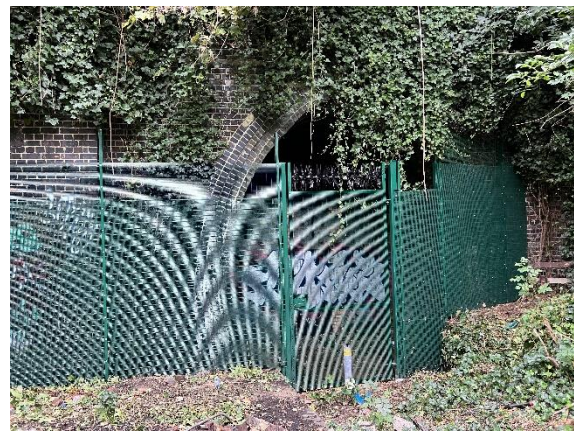
Figure 38 - Bollard in front of gate as an added layer of security.

The black section of works was the fencing carried out in front of the tunnels leading to Highgate depot. The length of this section was approximately 25 linear meters, and the scope of works was to install 3m high double skinned GCP 358 prison mesh fencing, 2No. standard sized gates and 2 No. Bollards as an added security measure to the gates.

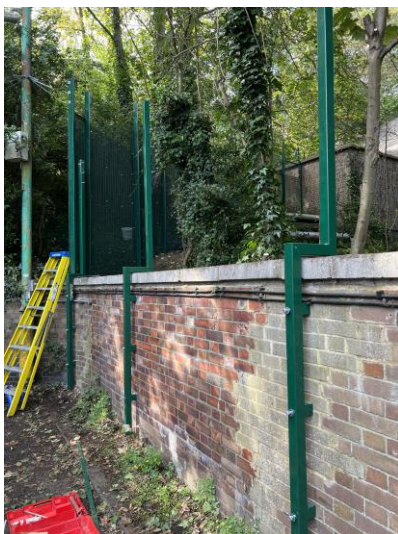
Figure 39 - Dog legged SHS posts resin fixed to car park perimeter wall.

In this section work was conducted to remove and replace existing barbed wire and posts fixed to the parapet walls around the bottom end of Highgate station car park. This Section spanned to approximately 60m of fencing. The scope of work carried included resin fixing dog legged SHS (Square Hollow Section) posts to the parapet wall to ensure access to service cables was sustained in addition to enhanced security. The dog legged posts were also to be fixed with double skinned prison mesh and topped with 3-strand barbed wire.

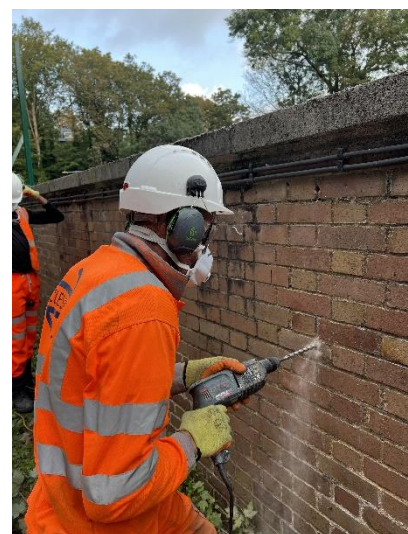
Figure 40 - Drilling 14mm holes for resin fixing.

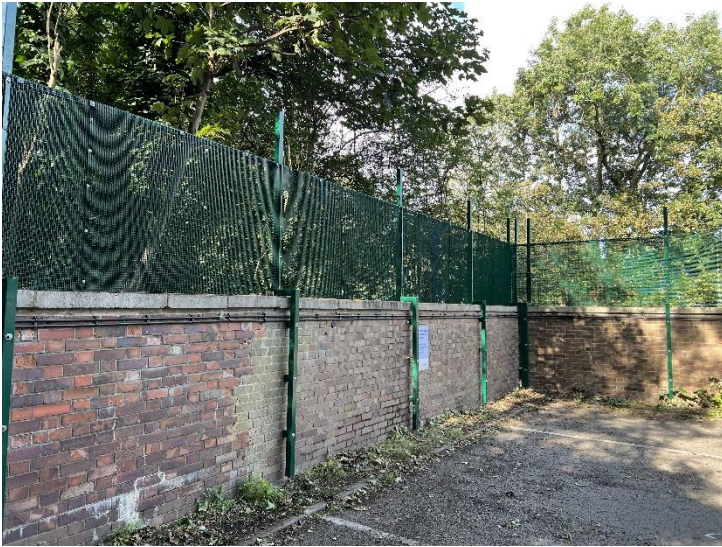
Figure 41 - Carpark fencing double skinned.

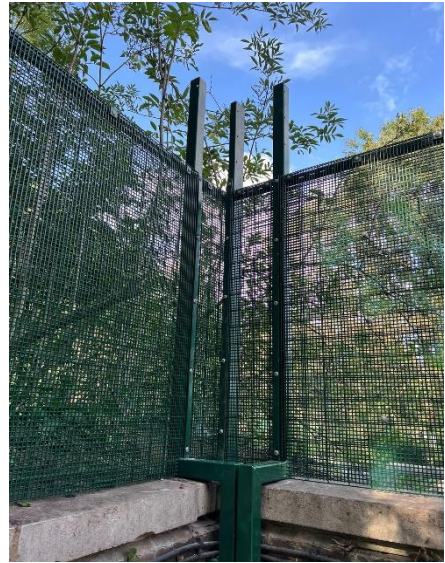
Figure 42 - Corner detail

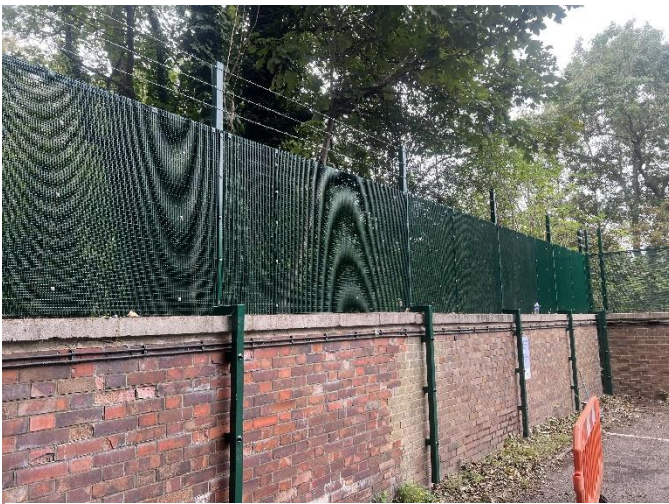
Figure 43 - Carpark fencing topped with 3-strand barbed wire.

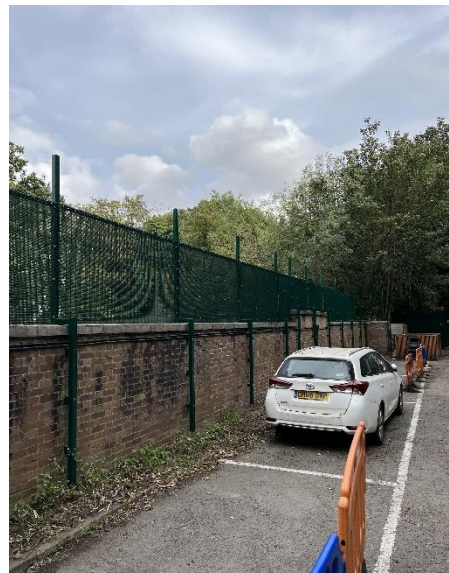
Figure 44 - Prefabricated double skin panels to avoid working at height.

- **Temporary car park space closures:** To ensure safety and an efficient system of work, It was authorised again due to the great work of Steve Witherspoon to close of a limited number of spaces along the parapet boundary during mobilisation of works along this section. This minimised the risk of any damage to cars whilst working in addition to creating a safer working environment with more space to carry out the fencing work.
- **Prefabricated double skin panels:** Panels were prefabricated with double skin prior to fixing them to the posts. This approach meant there was no requirement to work at height at all and completely mitigated any risks associated with working from heights.

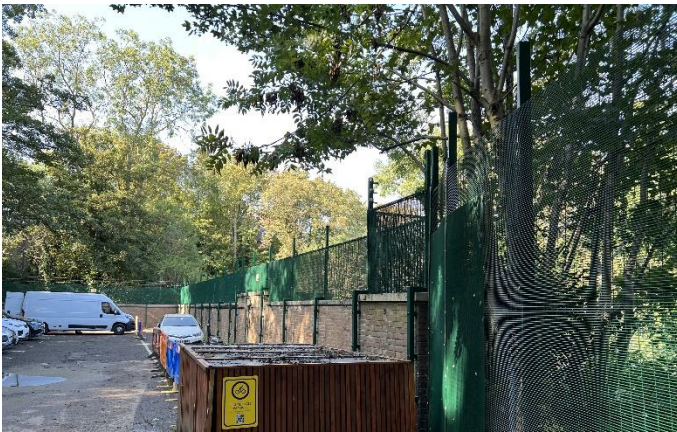
Figure 45 - Final section of fencing complete, adjoining the 'purple' and 'orange' sections.
